WPB Operations Fuel Canopy

STRUCTURAL INSPECTION REPORT

**Florida Department of Transportation
District 4**

October 2013

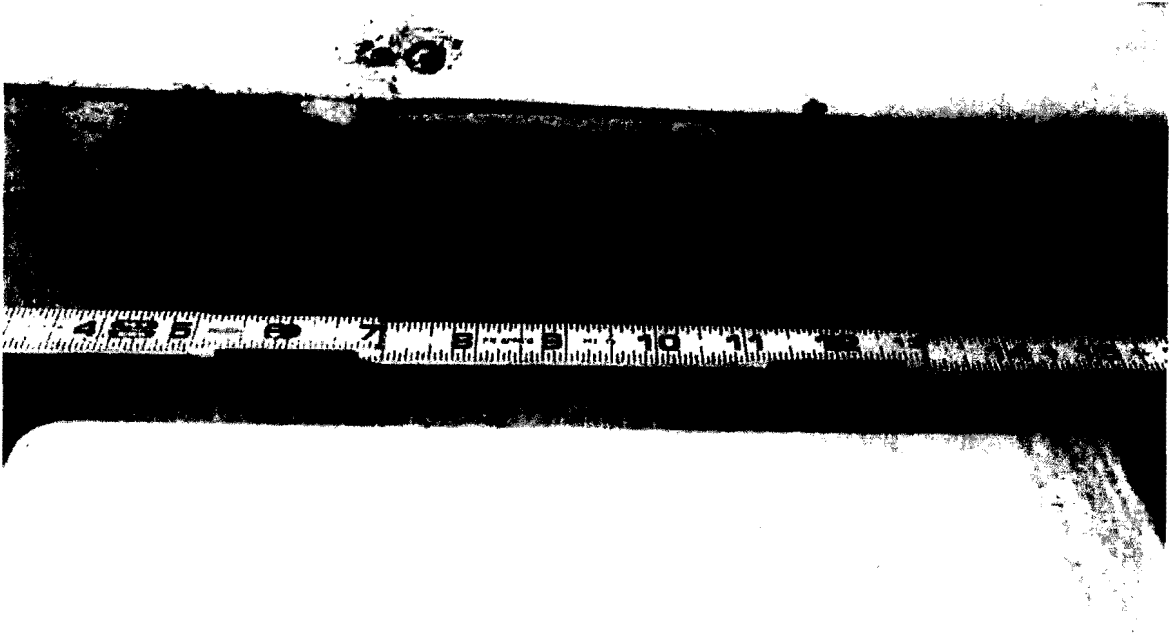
1. Column No. 2, east face, has a corroded area 12" W x H" with up to 1/8" section loss. Photo No. 3
2. Column No. 1, north face, has a corroded area 2.5"H x 7"W x 10"L with up to 1/16" section loss around drainage gutter. Photo No. 4
3. Column No. 4, east face at base, has corrosion and section loss due to water accumulation. A repair plate has been previously attached to the column bottom. Photo No. 5
4. Column No. 4, top east face, has a corroded area 6"W x 3"H with up to 1/16" section loss. Photo No. 6
5. Column no. 3, top east face, has a corroded area 3"W x 5"H with 100% section loss. Photo No. 7
6. Column No. 5, top east face, with typical corrosion due to water leakage at the gutter to column connection. Photo No. 8

As seen in the referenced photos columns 3 and 4 show corrosion and section loss due to the accumulation of water draining through the columns. At the top the damage occurs at the gutter to column connection for all columns. Only columns 3 and 4 show signs of corrosion at the base around the drainage holes. For the south and north columns the drainage pipes run through the footing pedestals and no apparent damage is visible. See Photo No. 9

Two repair details have been prepared to restore the capacity of the steel columns to pre-damage conditions. Refer to Repair Details Nos.1 and 2 in Appendix A.

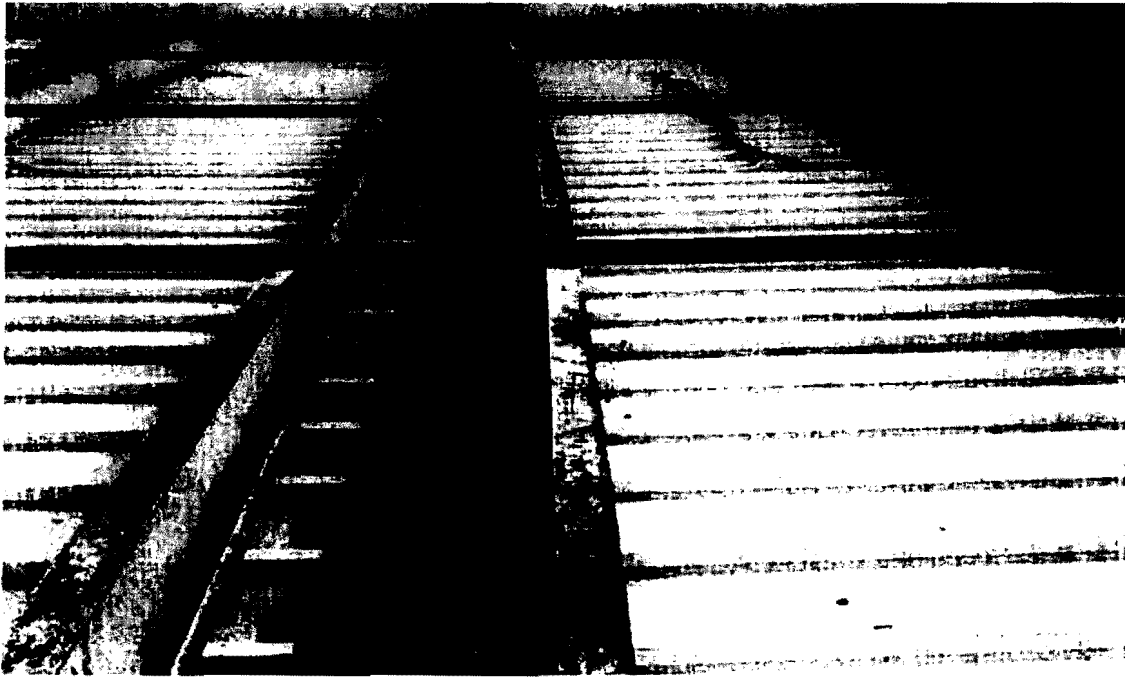
1. Stringer No. 4 at north end is bent approximately 2.5 inches. Photo No. 10
2. Stringer No. 3 at north end exhibits 20% section loss along the top section of the east bottom flange. The corrosion extends for approximately 22 feet of the beam flange. Photo No. 11

The canopy roof frame system structural steel shall be cleaned and coated in its entirety as per FDOT Specification Section 561. Repair to the damaged stringer bottom flange shall be performed as per Repair Detail No. 3 in Appendix A.

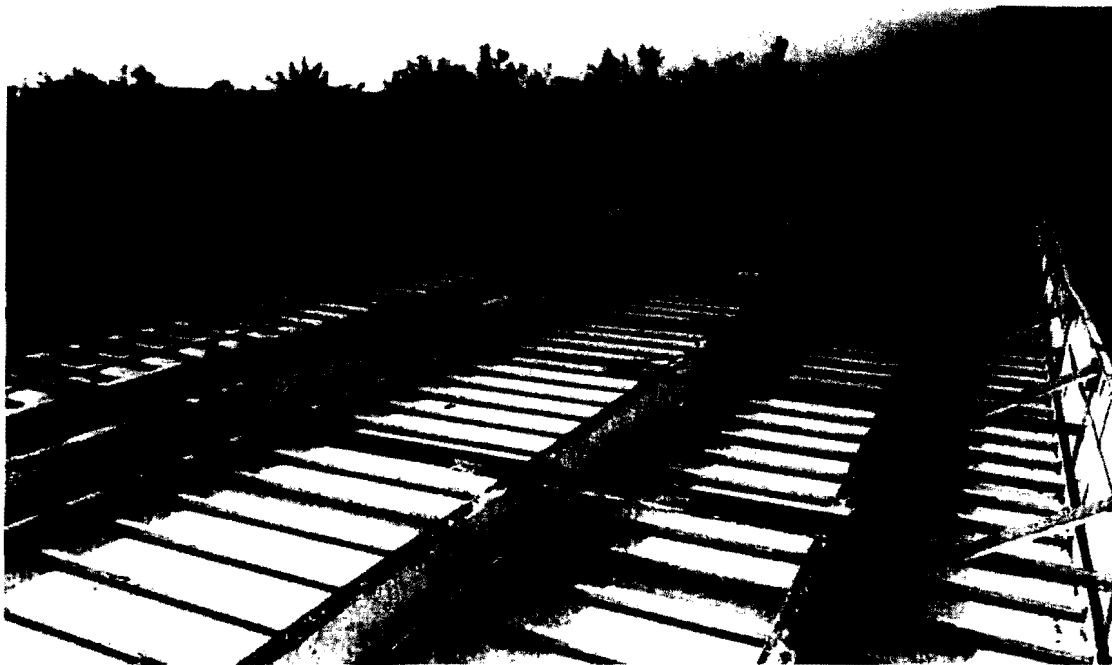
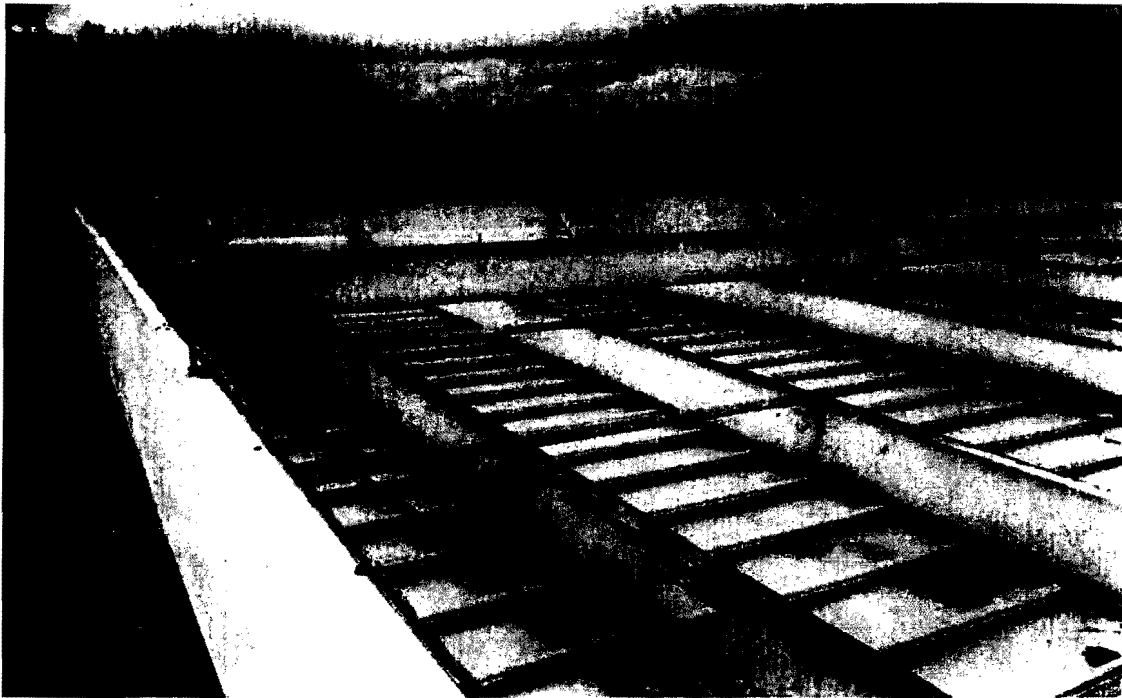
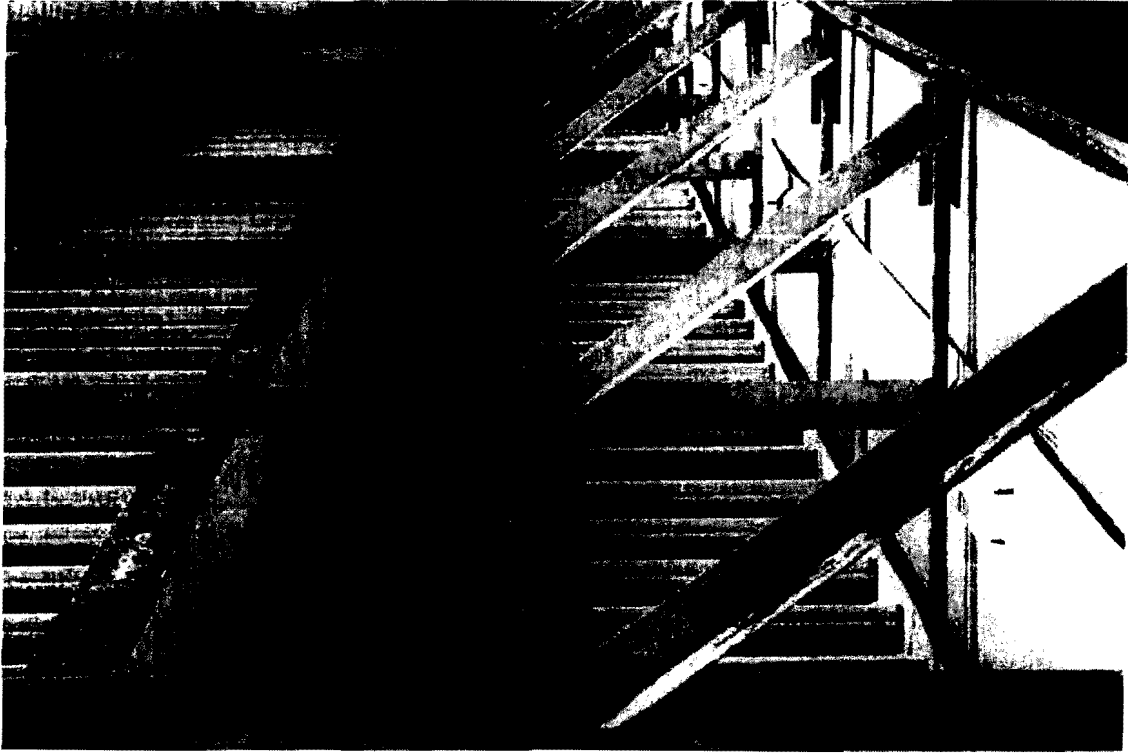
The canopy (fascia) bracing/framing exhibits extensive corrosion in the form of scaling and section loss. Section loss due to failure of the protective paint system and lack of maintenance is present over the entire roof. The bracing system consists 2" x 2" x 3/16" angles spaced at 5'-0" center to center extending from the fascia panels to the first and second stringers along the east and west sides of the roof and from the fascia panel to the last beam on the north and south side of the roof. Refer to Photo Nos. 12 thru 15.

The roof metal panel ceiling system and fascia panels shall be replaced completely with a similar roof fascia system. Replacing the entire roof system is necessary since partial repairs are not practical. The roof panels, the drainage flumes and fascia panel secondary members are extensively corroded at random locations. Replacement of the existing roof

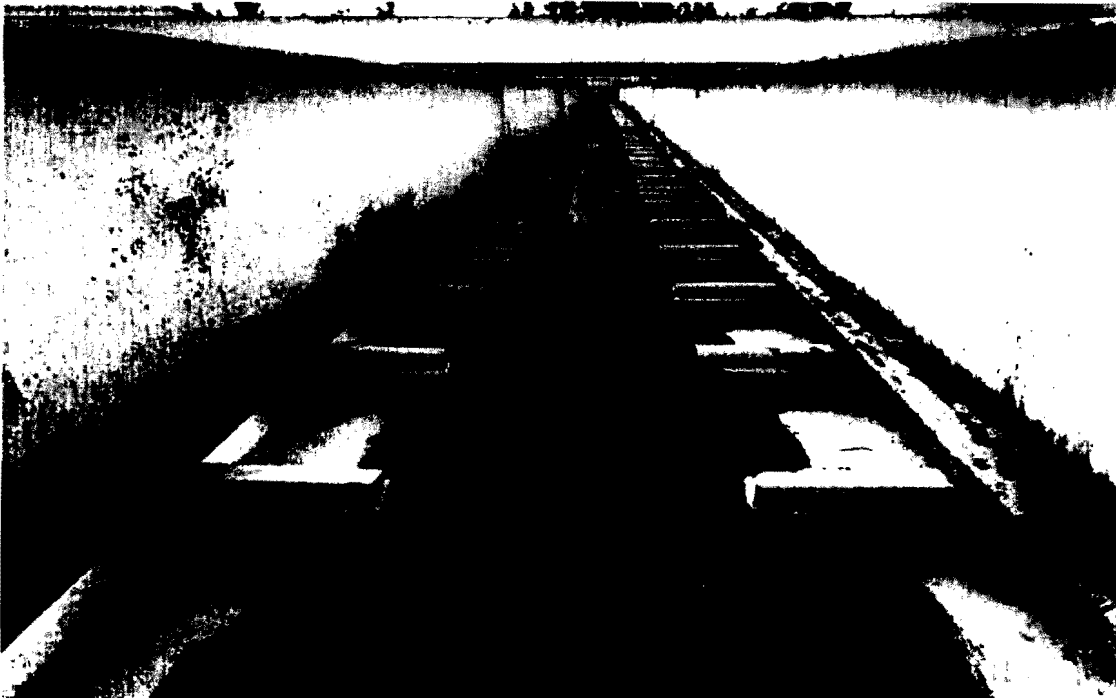
The roof drainage system consists of a longitudinal flume (gutter) running from north to south along the center of roof serving as a main water collector. Transverse flumes to each column are used to drain the roof runoff through the columns. The flumes show signs of water ponding, corrosion and leakage. Refer to Photo Nos. 16 and 17.

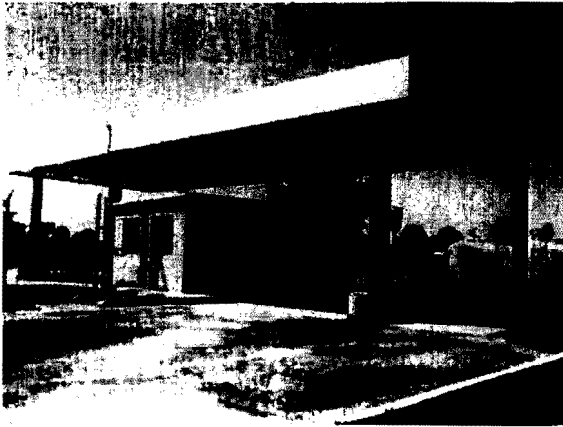
1. As we approach the fueling station right in front of the northeast corner column an area 5'x3' is covered by steel flaking coming out of an adjacent drainage opening. These corroding flakes are what prompted this inspection and can be seen also and the opposite end of the island.

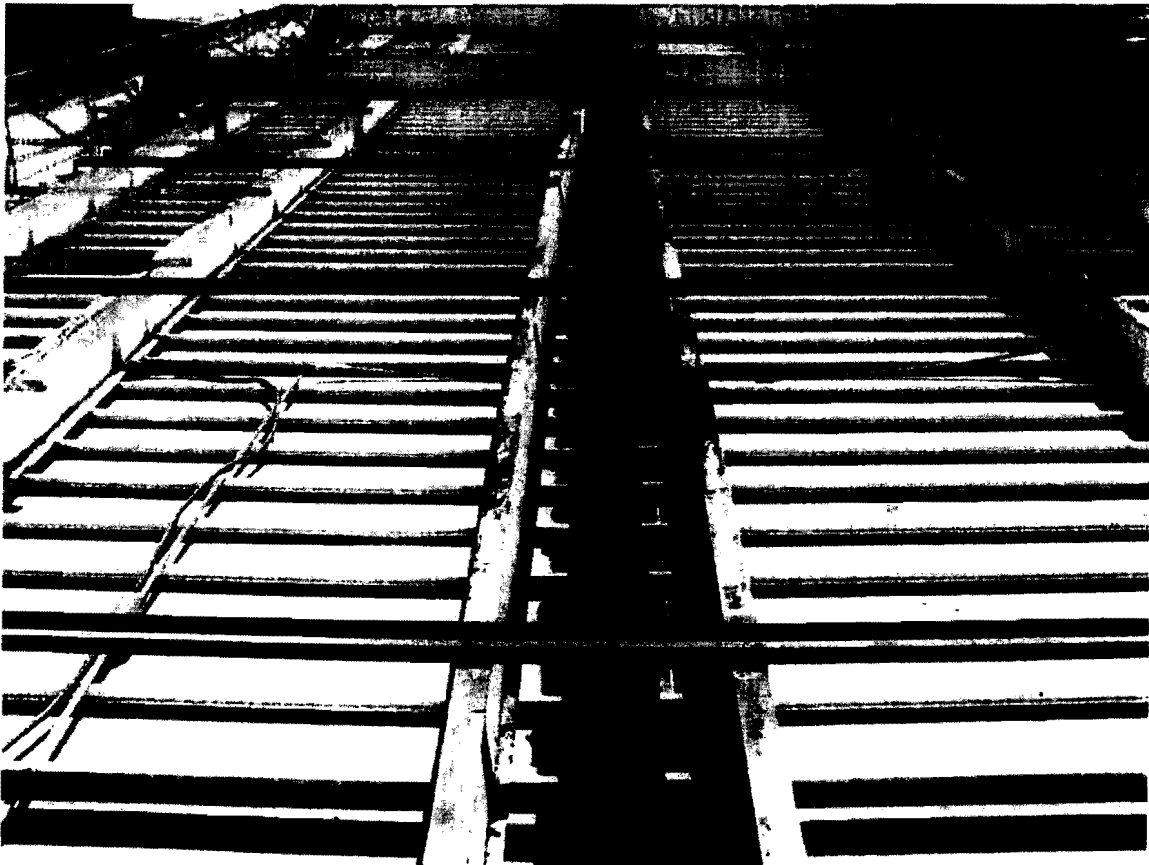
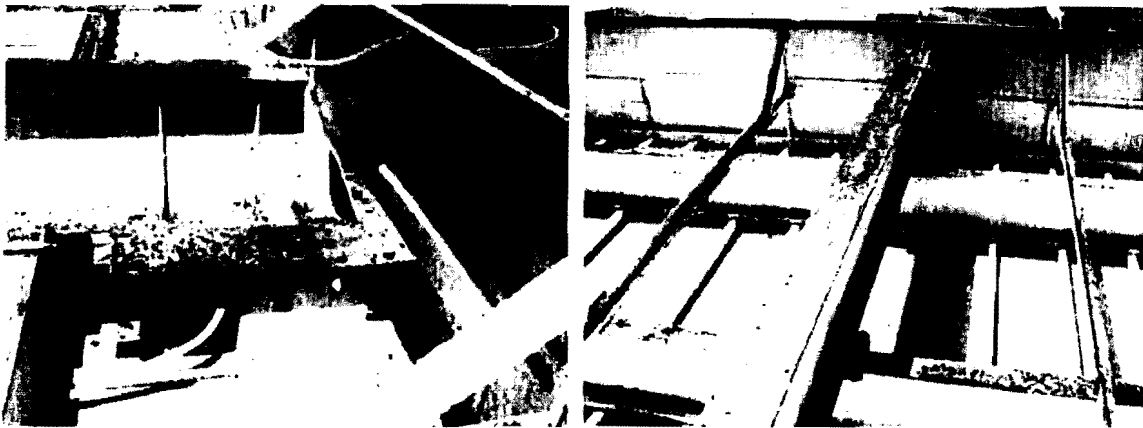
5. The super structure constructed of steel beams supported at the ends by the columns in a transverse direction (west to east) and steel stringers in a longitudinal direction (north to south) attached (hanging) to the bottom flange of the transverse beams. The beams, in general, are exhibiting minor surface corrosion of the web and flanges. The stringers, in general, are showing minor surface corrosion of the web and minor to moderate surface corrosion of the flanges with a localized area of the bottom flange with moderate to heavy surface corrosion in the form of pitting, scaling and section loss in the most severe spots due to the lack of a good protective recoating program of the steel surface.

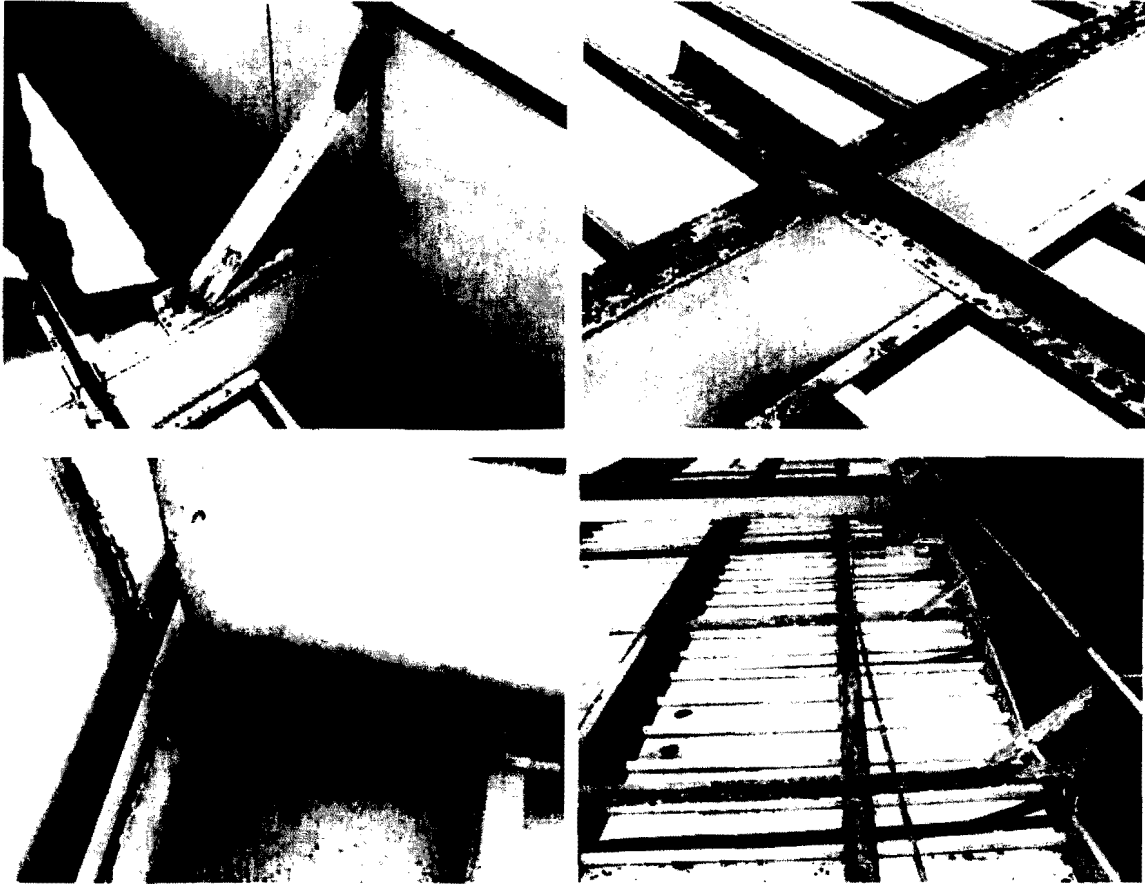
6. The canopy false work (fascia) bracing/framing and ceiling panels supporting members are exhibiting areas of heavy to severe surface corrosion in the form of heavy scaling and section loss, also due to the lack of a good protective recoating program of the steel surface and its resistance to storm winds may have been compromised due to its general condition. Illustrative photos of these deficiencies are offered below.
